**DEPARTMENT OF TRANSPORTATION**

Contract #: 04-0120F4Cty: SF/ALA Rte: 80 PM: 13.2/13.9File #: 82.28**WELDING INSPECTION REPORT****Resident Engineer:**Siegenthaler, Peter**Address:** 333 Burma Road**City:** Oakland, CA 94607**Report No:** WIR-018475**Date Inspected:** 29-Nov-2010**Project Name:** SAS Superstructure**OSM Arrival Time:** 700**Prime Contractor:** American Bridge/Fluor Enterprises, a JV**OSM Departure Time:** 1530**Contractor:** Westmont Industries**Location:** Santa Fe Springs, CA.**CWI Name:** Ruben Dominguez**CWI Present:** Yes No**Inspected CWI report:** Yes No N/A**Rod Oven in Use:** Yes No N/A**Electrode to specification:** Yes No N/A**Weld Procedures Followed:** Yes No N/A**Qualified Welders:** Yes No N/A**Verified Joint Fit-up:** Yes No N/A**Approved Drawings:** Yes No N/A**Approved WPS:** Yes No N/A**Delayed / Cancelled:** Yes No N/A**Bridge No:** 34-0006**Component:** Travelers**Summary of Items Observed:**

**SAS-EB Traveler****Fixed Stairs Section**

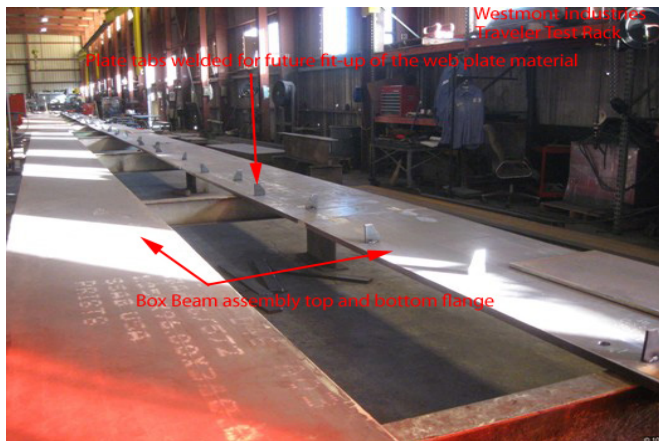
On this date, the QA Inspector observed WMI production personnel performing fitting, welding and cutting activities on various assemblies for the Traveler Test Rack.

See attached picture below.

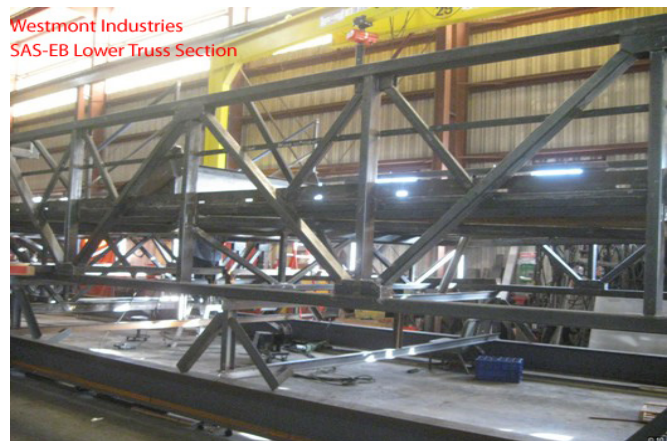
On this date, the QA Inspector observed Westmont Industries (WMI) production welder, Mr. Eutimo Lopez (WID # 3035), continuing to perform FCAW activities on the previously fit Frame assemblies, identified as 12-A240,

13-B240, 7-A225, 8-A226 and 9-A230. The QA Inspector observed throughout the shift, that the FCAW was being performed in various positions, on the connector plate and Tube Steel (TS) material fillet and flare groove welds.

See attached picture below.
